RAILWAY INVESTIGATION REPORT
R00M0007

COLLISION AND DERAILMENT

VIA RAIL CANADA INC.
PASSENGER TRAIN NO. 14
MILE 65.1, NEWCASTLE SUBDIVISION
MIRAMICHI, NEW BRUNSWICK
30 JANUARY 2000

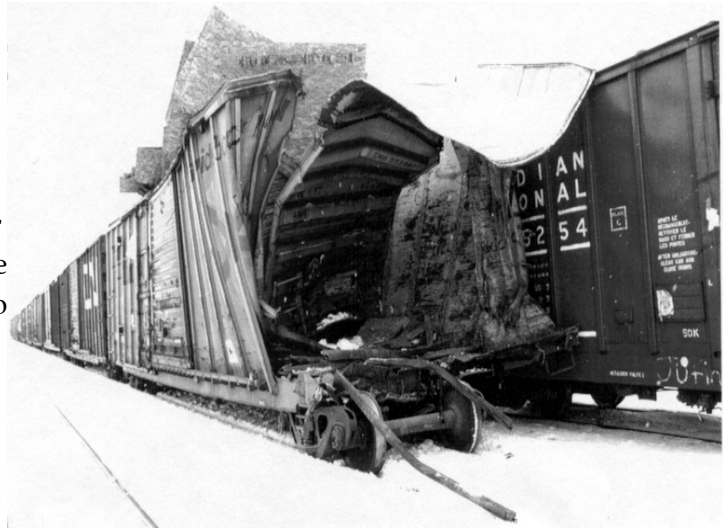
Photo 1. Damage to the first freight car (CNA 553997, loaded with fibreboard) struck by VIA 14 in track NC-22

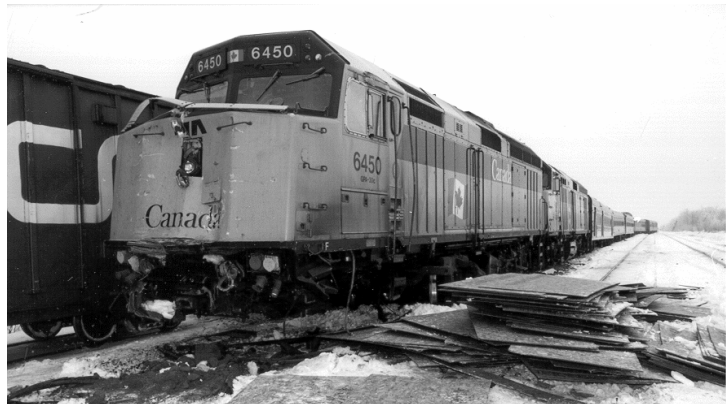
Photo 2. Some of the damage to lead locomotive VIA 6450. Note displaced front truck under centre of locomotive (which damaged the battery boxes and diesel fuel tank) and impact marks on collision posts on the front of the locomotive.

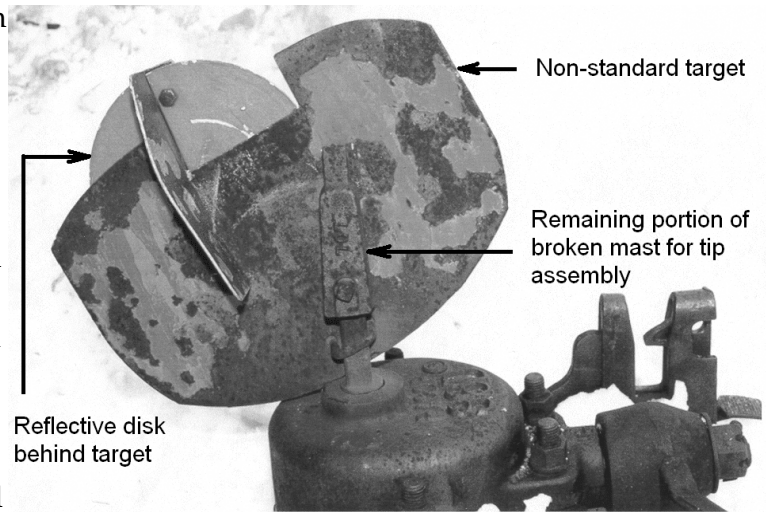
Photo 3 shows the condition of the target and tip assembly for the main track crossover switch at Mile 65.1 as found immediately after the accident. Examination of the mast extension, tip assembly, and target revealed the following:

The mast extension was 12 inches in length, not 25 inches as stipulated in the SPC. It was fractured in two pieces, one 7 inches long, the other 5 inches long. Construction was of forged steel with a cross-section measuring about $\frac{3}{4}$ inch square and about eight inches long with an integral one-inch-square socket and set screw. It conformed to a CN specification for a part to be used in a target tip assembly for forged switch masts, and was not designed for use with a large switch target. It was not painted black to SPC specifications, and was completely rusted, including the fracture surfaces. It was equipped with four bolt holes to permit the fastening of the tip targets directly to it by nuts and bolts.

Photo 3. Switch target and tip assembly from 36-D switch at the main track crossover at Mile 65.1 immediately after the accident, as viewed in the direction of travel by the VIA train crew

The red and green tip assembly attached to the larger broken piece of the mast extension was rotated 180 degrees and jammed down onto the red target, partially obscuring the red reflective surface of the upper tip assembly in the direction of travel of the approaching VIA train.

A red-painted sheet steel switch target, 10 inches high by 15 inches wide, was below the tip. It was of a slightly irregular shape and was loosely attached to the $\frac{7}{8}$ -inch-square vertical shaft (spindle) by a U-bolt. The set screw in the smaller broken mast fragment was used to hold the larger red target down on the spindle. Witness marks from rotational movement of the target against the tip mast were evident on the face of the painted red surface of the target.

- **Large Red Target:** This target was badly rusted to the point where only 20 per cent of the red paint remained on its rear face and about 25 per cent on its front face. This target also displayed numerous small, circular impact marks consistent with bullet impacts.

- **Red and Green Tip Assembly:** The top of this target was originally about 16 inches above the level of the adjacent track rail crown. After the fracture and temporary replacement, the top of the target was lowered another 3.5 inches over the circular red target.

- There were 13 small, circular-type spall impact marks on the rear face of the green plate, consistent with bullet impact marks. The front face of the target had also been hit once about one inch from the top by what appeared to be a large-calibre bullet which penetrated and tore out the plate to the edge. On penetrating, the bullet nicked the thread of the bolt beyond its penetration hole.

- It was concluded that the switch target and tip assembly provided were:
 - a) in a deteriorated and rusty condition for some time;
 - b) lower in height than desirable for optimum visibility in winter with banked snow alongside the tracks;

- c) broken off by a rifle shot, fracturing the support shaft, and temporarily repaired, thereby lowering the top targets 3.5 inches and partially obscuring the normal visibility of the circular, red target.

NBEC surveyed all main track switch targets and implemented a plan to repair and/or replace any that were in less-than-standard condition. All main track switches are now equipped with a regular-type switch stand mast with an elevated large target meeting the new CN specifications (diamond-grade material). Highly reflective material was added to all main track switch targets to increase their visibility, particularly in nighttime conditions. Improvements were also made to inspection procedures to ensure monthly focus on switch components on turnout inspection forms through the introduction of a switch inspection job aid (that is, switch stand mast, target, and tip assembly) to be used in addition to the standard turnout inspection forms.

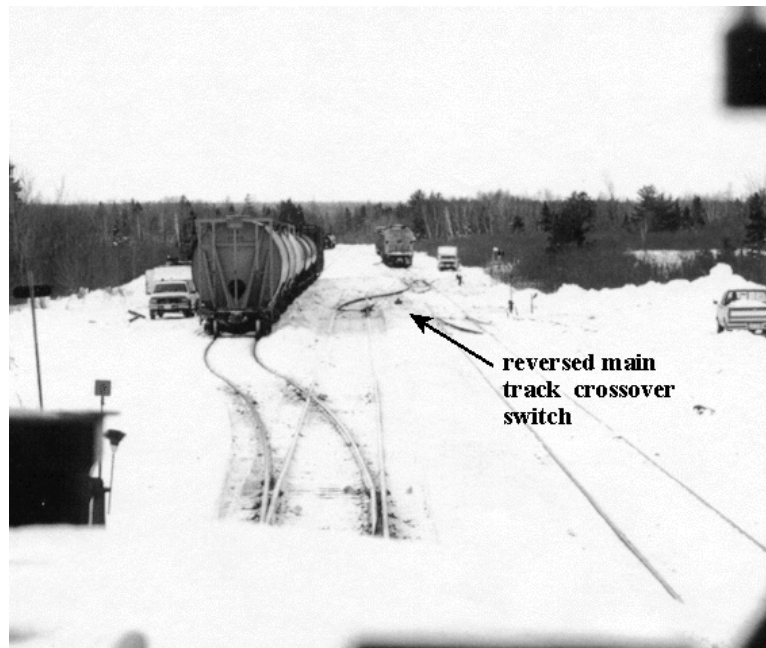
The colour and geometry of the non-standard target could first be seen from approximately 300 feet. At about 500 feet, the target was seen as black in colour and of no discernable geometry.

The colour and geometry of a standard switch arrangement in good condition could be seen from slightly less than 900 feet in the conditions that existed at the site.

Photo 4. View of main track taken from windshield of locomotive positioned near NC-23 switch. Note surrounding snow conditions and location of target for reversed main track crossover switch.

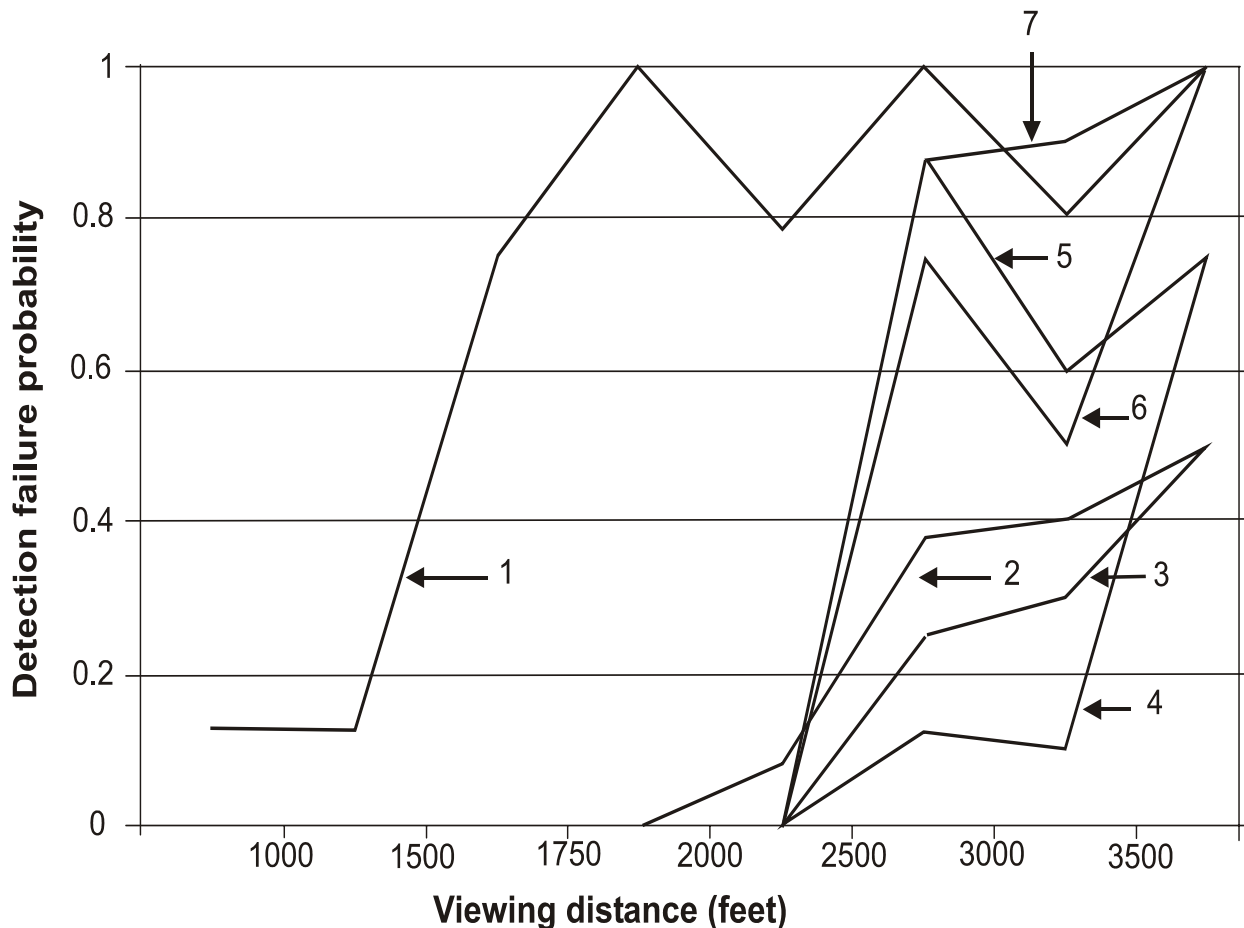
Figure 7. Probability of reversed target detection failure by viewing distance

It can be seen that, while reversed targets in good condition are detected without error at a distance of 2000 feet with tip reflectorization, and at 1750 feet with no tip reflectorization, the occurrence target (No. 1) is not detected error-free even at 500 feet. Even in the undemanding conditions of the Walkley Yard simulation, the occurrence target could only indicate switch position at less than half the distance of targets in good condition.⁵
